The Ingagane pipeline, which feeds the Ingagane Power Station from the Chelmsford Dam, could play a vital role in the supply of water to Newcastle and its surrounding communities. During 1996 Eskom handed over the Ingagane pipeline to the Umzinyathi Regional Council, and in doing so entrusted the Council with the responsibility of maintaining and operating the pipeline.

PIPELINE MAINTENANCE

by Craig Botha, Paradigm Projects

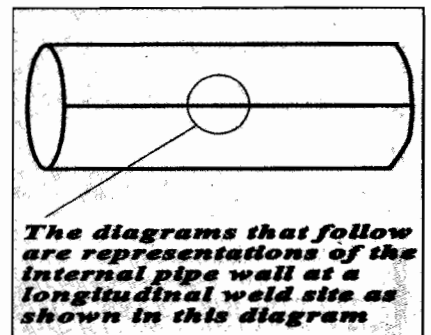
Figures 1 to 4 illustrate these observations: *Figure 1* shows a typical longitudinally welded length of steel pipe. The pipe is lined with bitumen as shown in *Figure 2*. The weld site chosen illustrates the catastrophic consequences of unchecked bacterial corrosion. As the bitumen lining loses its plasticiser

Figure 1: Typical longitudinally welded length of steel pipe

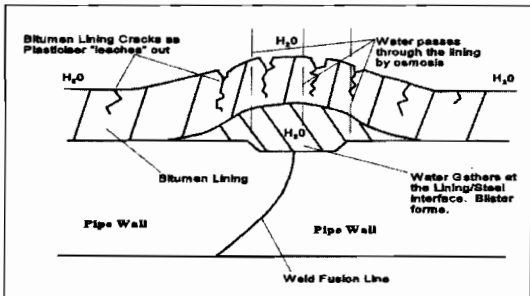
Figure 3

it begins to pass water by osmosis, resulting in a positive pressure between the steel surface of the pipeline and the lining. *Figure 3* is a simplistic representation of this process.

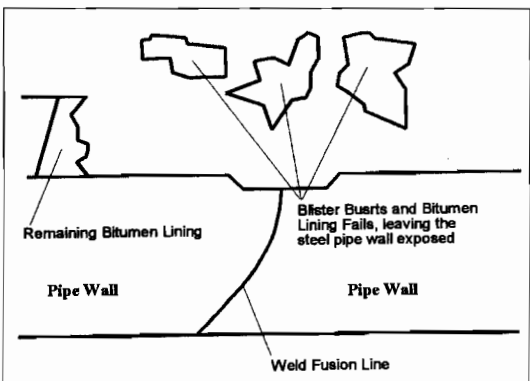
Figure 4

The process of osmosis continues until the adhesive strength and mechanical properties of the ageing bitumen lining are no longer able to withstand the positive pressure and the bitumen ruptures. The bitumen may break away completely, as shown in *Figure 4*, or may crack only as shown in subsequent photographs. The findings of the lining inspection for each of the inspection sites are detailed in *Table 3* where it is evident

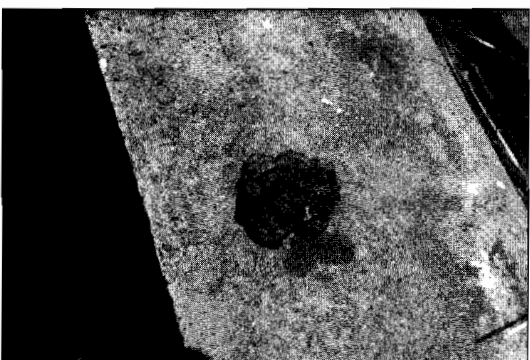
Figure 5

that sulphate reducing bacteria are well established within the pipeline. *Figure 5* depicts the bitumen lining condition and the presence of sulphate reducing bacteria. The bright metal surface displayed in *Figure 6* is an indication of severe corrosion and a metal loss of 2,5mm was measured at this location.

ineffective as a corrosion protection system. On this basis it was recommended that a suitable relining/coating system be considered to extend the life of the pipeline. The relining/coating system should take the following into consideration:

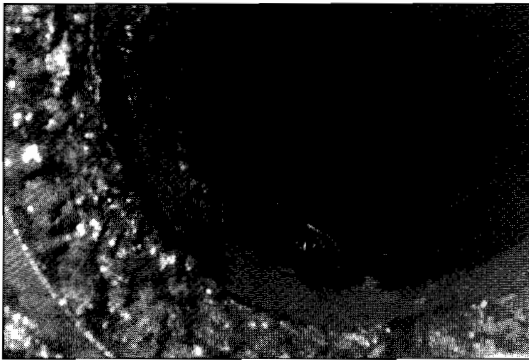
Figure 6: The bright metal surface is an indication of severe corrosion

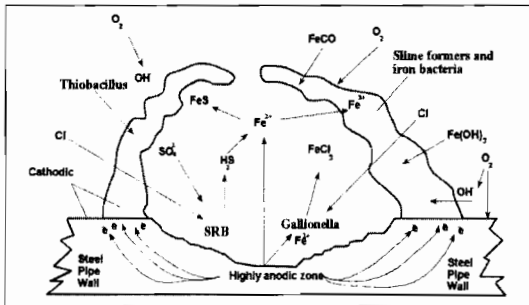
Sulphate reducing bacteria produce H₂S as a byproduct. This is highly soluble in water, forming dilute sulphuric acid at the steel nodule interface and resulting in rapid corrosion beneath the bacterial colony. *Figure 7* graphically illustrates the make up of a typical nodule.

Figure 7: Processes which could occur during pitting of iron or steel with biological activity
